# Manhole Inspection Summary

Manhole # S53K\_\_065MH

Insp Date: **4/9/08 8:20 AM**

**Location** Address: **3101 Fait Av**

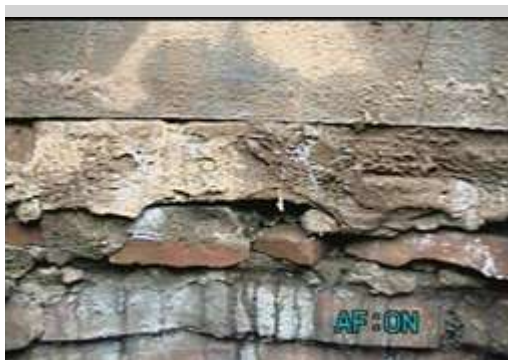
Defect 3

**Chimney / Frame Adjustment** ☒ Exists Material: **Brick** ☐ Parged Height: **5** (in.)

Condition: ☐ Sound ☐ Cracked ☐ Root Intrusion ☒ **Loose Brick** ☒ **Deteriorated**

chimney cond loose bricks, chimney cond deteriorated

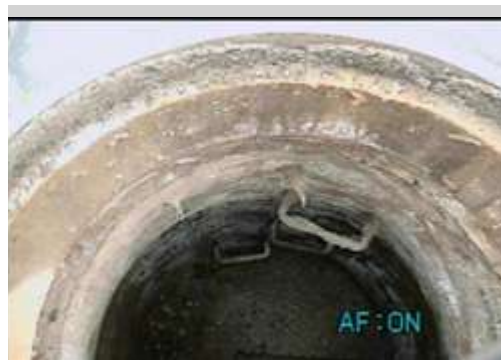
Defect 2

**Steps** Count: **5** Missing: **2** ☒ **Corroded**

corroded and missing steps

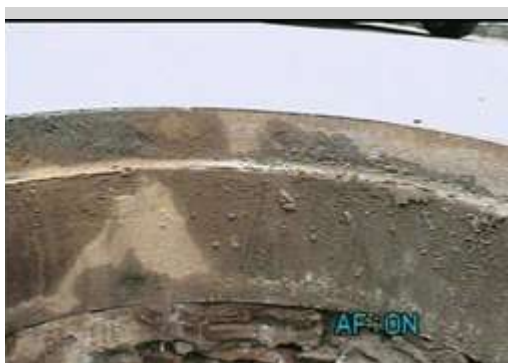
Defect 1

**Frame** Offset: **0** (in.) Condition: ☐ Sound ☒ **Cracked** ☐ Leaks

crack in frame
